Manhole Inspection Summary

Manhole # S49CC_019MH

Insp Date: **2/15/08 10:29 AM**

Location Address: **Glover**

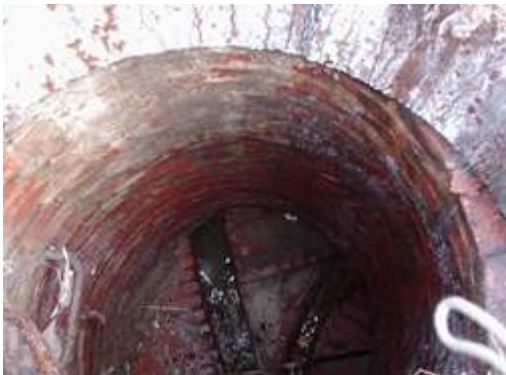
Defect 2

Frame Offset: **3** (in.) Condition: ☐ Sound ☐ Cracked ☒ **Leaks**

Frame Leaks

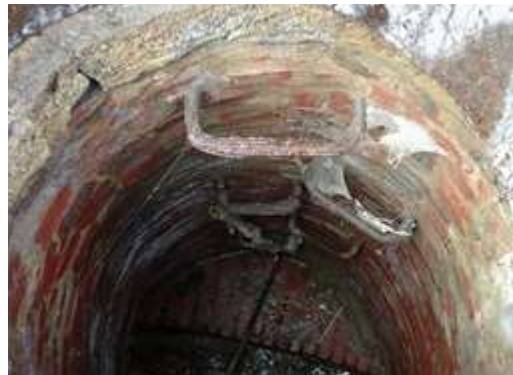
Defect 1

Condition: ☐ Sound ☐ Cracked ☐ Root Intrusion ☐ Loose Brick ☒ **Deteriorated**

Infiltration: ☐ None ☒ **Joint** ☐ Cracks ☐ Mortar ☐ Roots ☐ Wall

Adjustment Joint

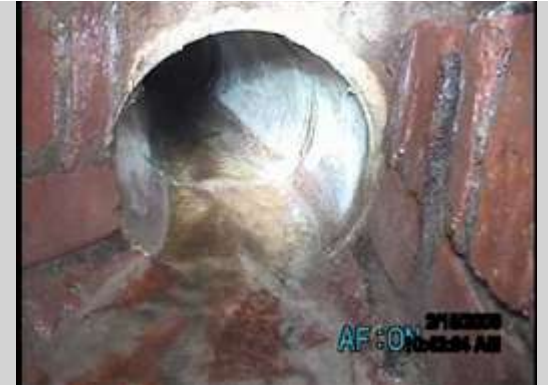
12 O'Clock Outflow

8 in. Circular Gravity Sewer
Pipe Out @ 12 O'Clock

Pipe Height: **8.4** (in.) Rod and Bar (Angled)
Pipe Material: **Clay** ☐ Pipe Lined
Invert Depth: **9.45** (ft.) Flow Characteristics: **Fast**
Deposits: ☒ None ☐ Mud ☐ Sludge ☐ Debris ☐ Grease
Silt Depth: (in.) Deposits Extent:
Infiltration: **None** Pipe Seal Cond: **Sound**

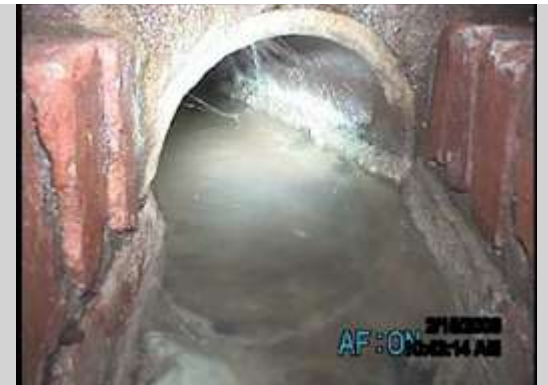
6 O'Clock Inflow

8 in. Circular Gravity Sewer
Pipe In @ 6 O'Clock

Pipe Height: **8.4** (in.) Rod and Bar (Angled)
Pipe Material: **Clay** ☐ Pipe Lined
Invert Depth: **9.40** (ft.) Flow Characteristics: **Fast**
Deposits: ☒ None ☐ Mud ☐ Sludge ☐ Debris ☐ Grease
Silt Depth: (in.) Deposits Extent:
Infiltration: **None** Pipe Seal Cond: **Sound**

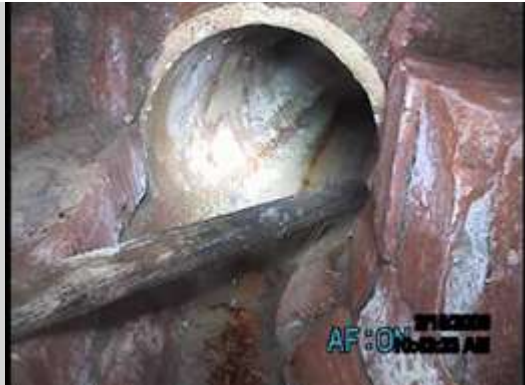
8 O'Clock Inflow

Pipe In @ 8 O'Clock

Infiltration: **None** Pipe Seal Cond: **Sound**
